INVESTIGATION OF A FAILED RAILCAR WHEEL: CORROSION PITTING FATIGUE

ESi investigated the root cause of a failed railroad wheel and determined that the reason for the failure was environmental rather than a result of human error.

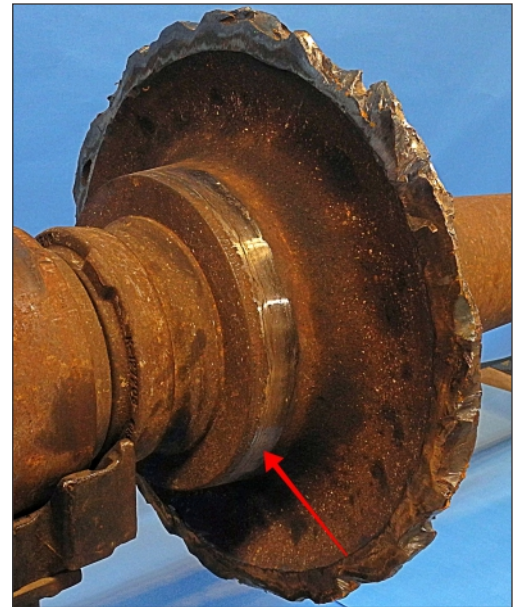
During the inspection of the wheelset, ESi determined that the fracture surfaces on the hub side were consistent with mechanical damage incurred when striking the track structure while rolling on the rail. As a result, the fracture surfaces did not reveal any new information.

Hub and partial plate section of failed wheel; arrow shows the wear from riding on the rail.

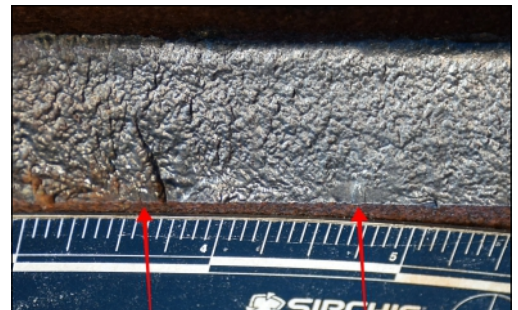
- Fatigue fracture, characterized by small smooth half circles or dimples at the initiation location; these microvoids occur prior to crack formation and rapidly transition to ductile failure
- Ratchet marks, indicating multiple initiation sites
- No indentations or signs of a plate strike on the front plate face
- Corrosion induced pitting on the plate surface at the fracture initiation location

Close-up of two fracture initiation locations.

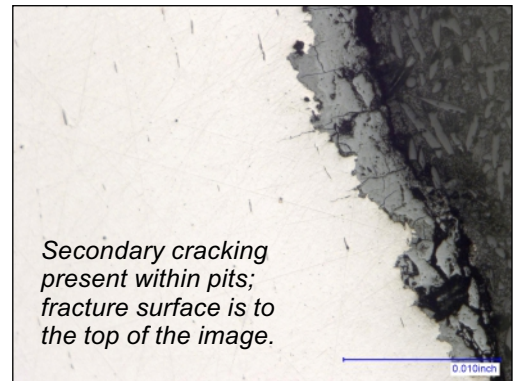
A section of the plate surface was removed and inspected using a digital microscope. The fracture surface had been rubbed for some time, causing loss of definition in the finer features. ESi prepared metallographic mounts to inspect the fracture initiation area, and observed that the cracks had started at the pits. Secondary cracking was also present near the fracture initiation location. The microstructure was consistent with pearlite, and the amount of decarburization on the fracture initiation side was less than on the opposite side of the wheel.

The curved plate wheel design utilized by AAR allows the wheel plate to flex. The flexing causes tension on one surface of the wheel plate when the opposite side is subjected to compression. While this tension is within expected performance parameters, wheel plates with pronounced corrosion pitting may experience plate-initiated fatigue cracking. In this situation, the wheel failed due to corrosion pitting, which initiated a fatigue crack on the back-plate face of the wheel. Secondary cracks from the corrosion pits were also noted in the area and on the opposite side of the wheel.

Secondary cracking present within pits; fracture surface is to the top of the image.
