## SPINAL FUSION BONE MILL ANALYSIS

Metal fragments were found in the milled bone used for spinal fusion surgeries. ESI's in-depth metallurgical and design analysis cleared the OEM of breach of contract and anti-competitive practice lawsuits brought by the bone mill subcontractor.

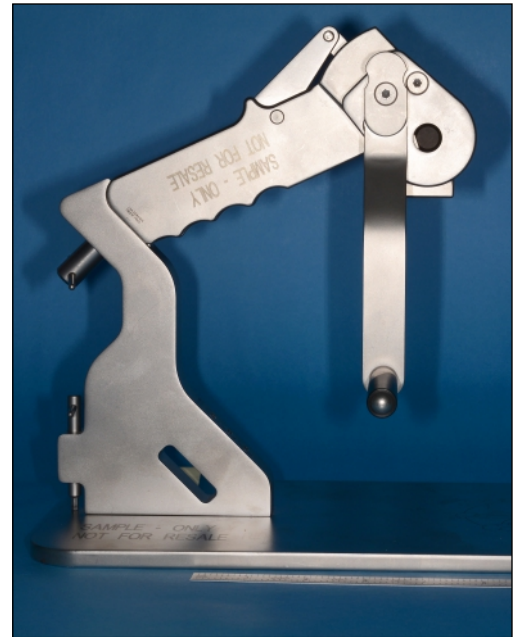
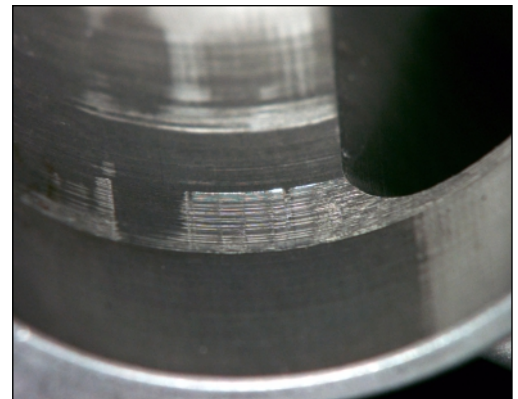
Abrasive wear of the bone mill housing was observed. Abrasive wear is caused when two surfaces in relative motion come into contact and the harder material cuts away the softer material. The locations of the wear scars were similar on all three of the used bone mills. SEM/EDS results indicated that the metallic wear particle widths were consistent with wear scars on the bone mill housing and that the base metal of the metallic particles is consistent with the Type 17-4 PH stainless steel used to make the bone mill housing, rather than the much harder Type 440C stainless steel cutting blades.

Design analysis, finite element analysis, and CMM measurements revealed that the root cause of the abrasive wear is interference between the hard cutters and the bone mill housing due to several design and manufacturing errors. The bone mill design lacked requirements on position control, flatness, parallelism, run out, concentricity, and straightness that enabled cutting plate-to-housing contact and wear. Tolerance stack-up errors exacerbated the severity of the part interference and wear. In addition, the bone mill components were not manufactured to the dimensional specifications which further exacerbated the amount of interference and abrasive wear.

*Interference between cutting plates and type 17-4PH SS housing.*

Simple design changes, such as the use of dowel pins to assure alignment of parts and the use of a one-piece integral shaft and cutters, would have remedied many of the issues.

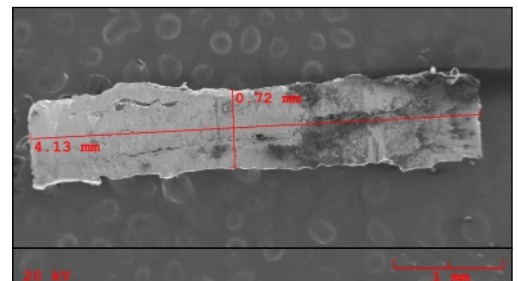
*The width of the metal debris is consistent with the width of the Bone Mill cutting teeth.*
