## SOURCE OF DAMAGE DETERMINED FOR GAS TURBINE ENGINES

An ESi investigation proving manufacturer defect prior to transport damage results in a reduced claim settlement for the client.

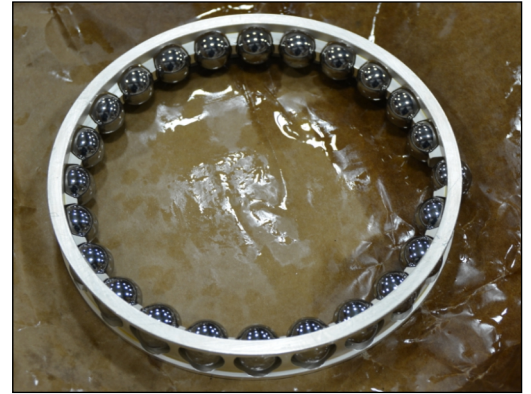
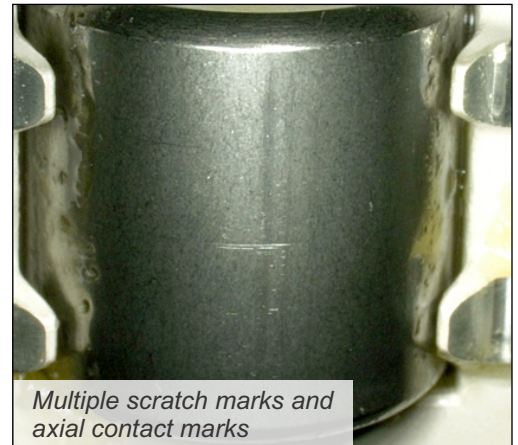
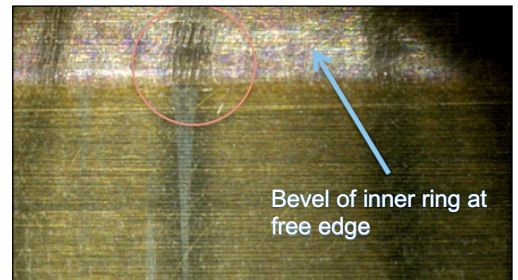
This inspection showed distinct marks related to the installation of the units in the form of brinelling, or permanent indentations, and sliding marks on the inner ring, emanating from the free edge of the inner ring towards the raceway. It also indicated brinelling marks on the inner ring's raceway due to shock loading. ESi also identified false brinelling and fretting, or wear and corrosion, on the inner ring and rollers relating to vibratory transport damage.

The observed shock and vibration damage could have been related to either the delivery or return trip. However, the observed sliding damage and circumferential dimpling of rollers was clearly related to original assembly and test operation of the units. The vibration analysis also addressed some erroneous data filtering statistics produced by the insured.

ESi determined that the primary damage to the turbines was related to installation, followed by subsequent damage to the rollers and raceway during their factory test run, where scratches formed on the rollers and pear skin was observed on the most damaged inner raceways.

These damage patterns were then later supplemented by some shock load related damage. In some cases this caused a single brinelling mark while in other cases multiple marks were clustered into a multitude of narrow bands on the raceway of each bearing. The identification of brinelling marks on the main thrust bearing indicated a severe shock load event commensurate with an event recorded on the return trip.
