## JET FIGHTER ACRYLIC CANOPY FAILURE

### SITUATION

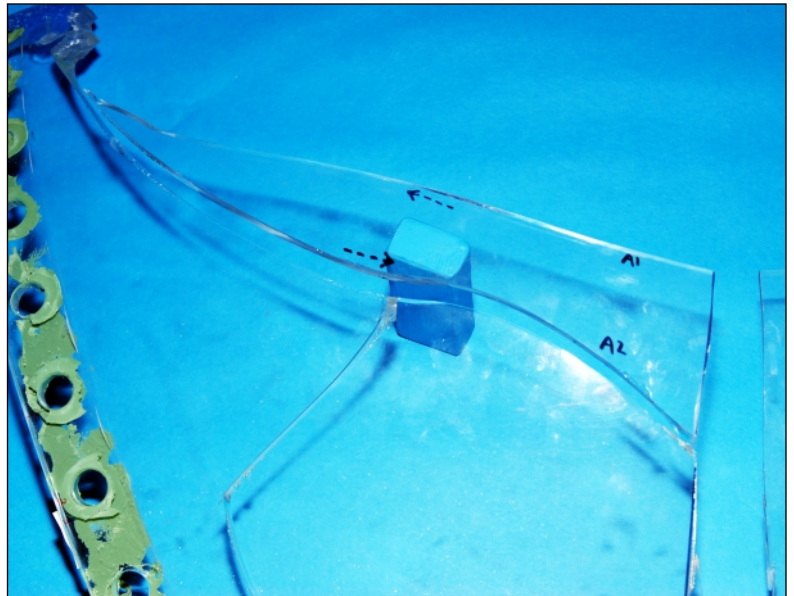
The analysis included macroscale (unaided eye and stereomicroscopy) and microscale (scanning electron microscope) fractographic examination of the failed canopy and comparison to laboratory-induced monotonic (single load application) overload and environmental stress cracking (ESC) fractures. Chemical [Fourier transform infrared analysis (FTIR) and energy dispersive spectroscopy (EDS)], thermal [differential scanning calorimetry (DSC)], mechanical (tensile, Izod impact, and fracture toughness), and chemical compatibility testing were also performed on the canopy assembly materials (transparency, sealant, adhesive, rubber and fasteners) to determine if material degradation played a role in the failure. Stress analysis, including finite element analysis and a fracture mechanics assessment, was utilized to characterize the in-flight stresses and to estimate a critical flaw size.

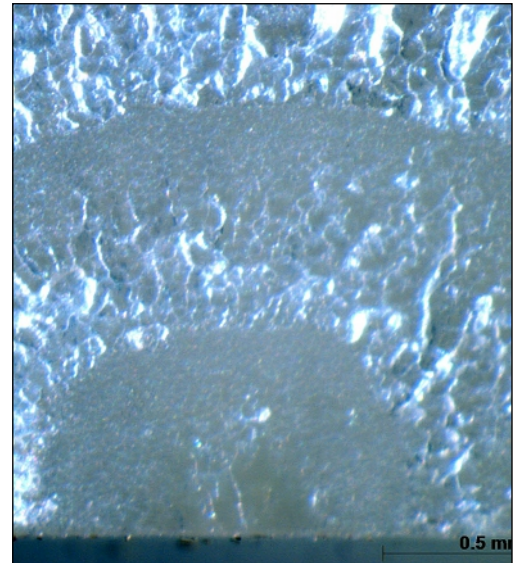
The fracture surfaces of the failed transparency displayed features indicative of monotonic overload failure initiating at the fastener holes under bending loads with the transparency inner surface under tension and the outer surface under compression. No evidence of fatigue or environmental stress cracking was observed. The numerous chemical, thermal, and mechanical tests conducted indicated no evidence of material degradation occurred due to weathering, oxidative aging, heat aging, or physical aging. Stress analysis demonstrated that the added stress due to pressurization was very low (<200 psi). Furthermore, the predicted in-flight stresses in the transparency were much lower than the material tensile strength. The critical flaw or crack size was determined to be approximately 0.05 inch (1.3mm).

The most likely failure scenario is the existence of crack-like defects combined with the decrease in fracture toughness due to low temperature (high altitudes) and/or exposure to detrimental chemicals (i.e., stress cracking agents). Procedures were recommended to assure that any crack-like indications were <1mm and that the transparencies would not be exposed to detrimental chemicals.
