## SEVERE, LOCALIZED WATERSIDE CORROSION TO BOILER TUBES

Localized corrosion to carbon steel boiler tubes was the result of localized boiling and scouring of protective oxides on the tube wall. Metallurgical and chemical analysis revealed no indication of stress-induced failure. Rather, better monitoring and control of the firing rate, water circulation, and oxygen monitoring was recommended to reduce future corrosion occurrences.

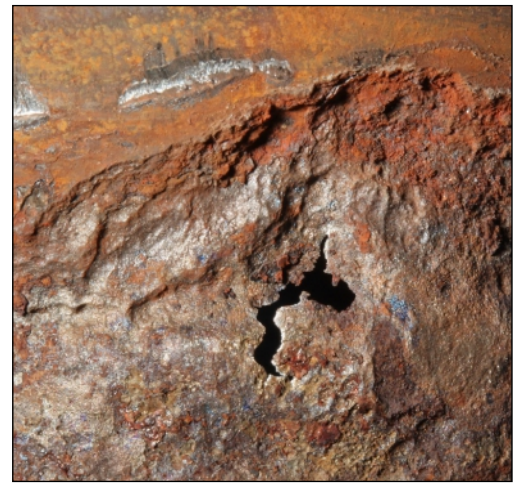
One of the failed boiler tubes was submitted to ESI's laboratory for analysis. The tube measured nominally 2.5 inches in diameter with a 0.10 inch wall thickness. It exhibited a smooth deformation band around the end where it had been roll-expanded into the tube sheet. Severe corrosion was evident to the outside of the tube immediately adjacent to the tube sheet interface that formed a crater at the top half of the tube circumference. The corroded area exhibited a mostly scale-free, pocked surface with a through-wall perforation at the bottom of the crater.

Submitted boiler tube exhibiting corrosion.

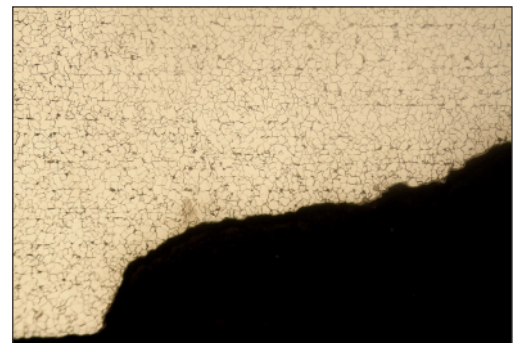
The severe, localized corrosion of the boiler tube wall indicated that the operating environment at that location was obviously different than the remaining portions of the tube. Evidence of corrosion on the top, inlet end of the tube coincided with the highest temperature of the tube where the hot combustion gases enter. The relatively scale-free surfaces in the corroded area of the tube was consistent with a scouring mechanism being at work. The localized situation likely caused localized boiling along the tube surface, causing a scouring effect to the protective oxide films that normally develops, thereby promoting localized corrosion. This situation would explain the observed localized corrosion at the same location on multiple tubes which are operating under the same conditions.

Cycling of the boiler to meet steam demand may have caused high heat input into the tubes and contributed to incidents of localized boiling. Alternatively, poor circulation of water along the tube sheet was suspected of causing low flow or stagnant conditions that promoted corrosion. A stagnant water condition was suggested by rust streaking from a smaller area of pitting on the submitted tube.

Corroded area of tube showing through-wall perforation.
