DIE CAST ALUMINUM BACKING PLATE CRACK EVALUATION

SITUATION

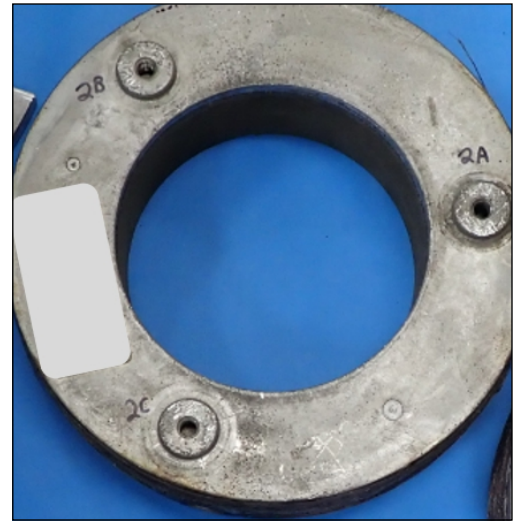
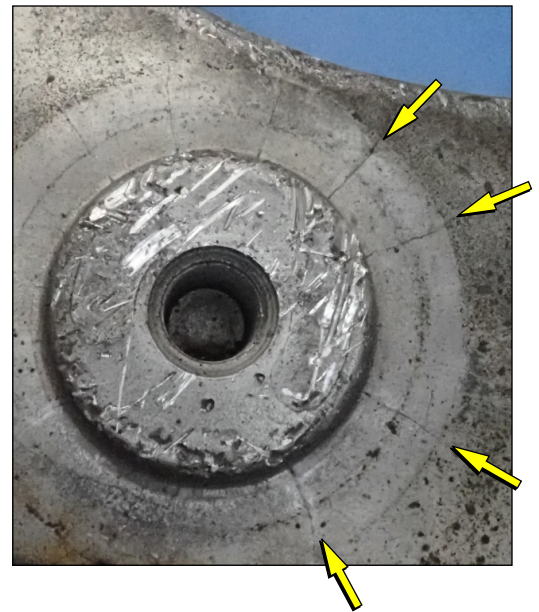
Crack-like indications were noted on a shipment of grinding stones. They were observed on the aluminum backing plate near the mounting bosses. This raised safety concerns with a European customer, given the more densely populated railroad operations in Europe in contrast to domestic US operations.

The metallographic mounts showed that the maximum depth (or protrusion in some cases) was < 0.003" on all samples examined. This indicated the die cast aluminum backing plates met the requirements of a maximum surface flaw of 0.006".

- A process to examine the crack-like indications of the die cast aluminum backing plates was developed.
- This process, although destructive, did not exacerbate the crack-like indications that were present.
- The parts met the surface roughness requirements of the drawing.
- The parts met the maximum allowable surface defect criteria on the drawing.
- The crack-like indications noted were actually surface impressions attributed to heat checking of the die casting tooling.

It is well understood that steel tooling used in the die casting process will develop heat checking after a high volume of parts have been run. The client indicated that after > 100,000 parts, this heat checking phenomenon had been previously observed. This was an indication that the tooling would require maintenance in the near future.
