## **GEAR FAILURE IN A MARINE STERNDRIVE UNIT – SINGLE EVENT OR WEAR AND TEAR?**

Broken gear teeth from the clutch mechanism of a marine sterndrive unit were analyzed and determined to be a result of long-term wear leading to fatigue cracking of the gear teeth. Analysis found no evidence of impact type damage or cracking to the gears or other drivetrain parts of the sterndrive to indicate failure initiated from a reported propeller strike. The gear tooth fractures were consistent with an end-of-life failure of the gear set.

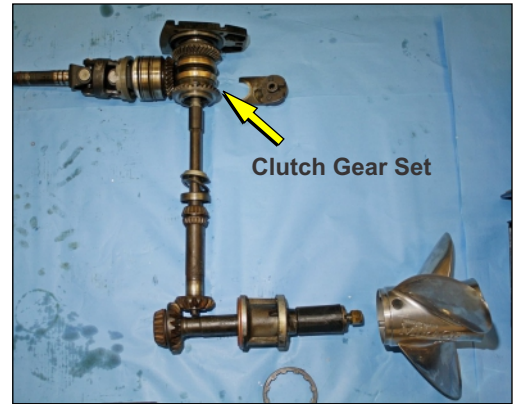
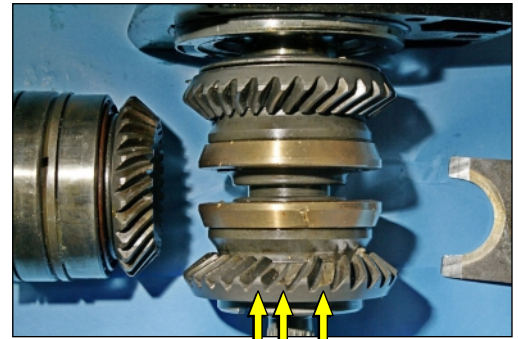
A teardown inspection of the sterndrive unit revealed three teeth on the lower clutch gear had fractured and the separated teeth were broken into various pieces, some of which jammed the shift mechanism. Each of the gear tooth fractures exhibited relatively smooth, transverse fracture surfaces exhibiting concentric beachmark features characteristic of fractures caused by high cycle fatigue crack propagation. The cracking had originated at the root radius on the load-side of the gear teeth, and was evidence of tooth bending fatigue. Examination of the fractures by optical stereomicroscope and scanning electron microscope (SEM) revealed transgranular fracture consistent with fatigue crack propagation. Small, parallel steps referred to as ratchet marks, were evident at the fracture origins that resulted from multiple, closely spaced fatigue crack initiation sites. There was no evidence of overstress cracks at the fracture origins, such as from impact loads induced by a propeller strike, that could be related to the initiation of fatigue cracking.

Clutch gear set – broken teeth on lower gear.

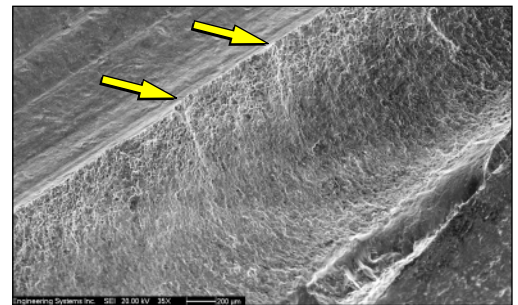
SEM photo of gear tooth fracture, showing ratchet marks at crack origin.

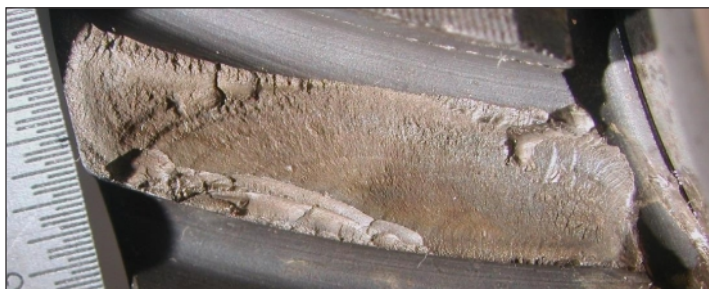
Inspection and analysis of the submitted marine sterndrive unit revealed fracture of several gear teeth of the lower clutch gear. The gear teeth fractures were a result of fatigue cracking caused by high cycle bending stresses. Surface cracking and spalling observed on other gear teeth, characteristic of surface contact fatigue, and advanced overall wear to the gear set was evidence of long-term usage and indicative of an end-of-life failure of the gear set. The gear failure was not related to a single, high-load event such as a propeller strike.

Gear tooth fracture, showing beachmark features characteristic of high cycle fatigue.

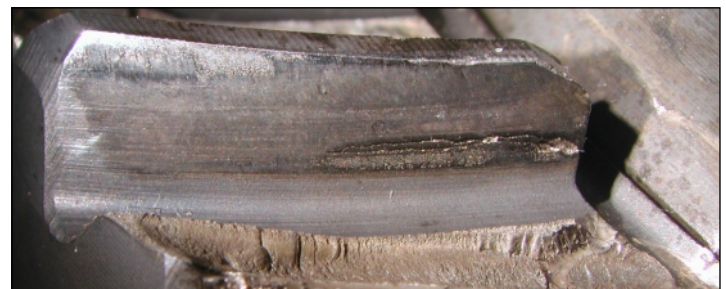
Other relevant evidence to the failure cause was the broad gear mesh contact pattern on the clutch and pinion gear teeth encompassing nearly the entire width of the gear teeth, indicative of extensive service. In addition, the face of several non-broken gear teeth exhibited areas of pitting and surface spalling that was characteristic of surface contact fatigue as results from long term wear.

Secondary gear tooth damage consistent with long-term wear.
