POWERPLANT SUFFERS EXTENDED DOWNTIMES & RECEIVES FAVORABLE SETTLEMENT AS FORCE MAJEURES

Two landfill gas process equipment failures at an electric powerplant cause significant unplanned downtimes and substantial repair procedures.

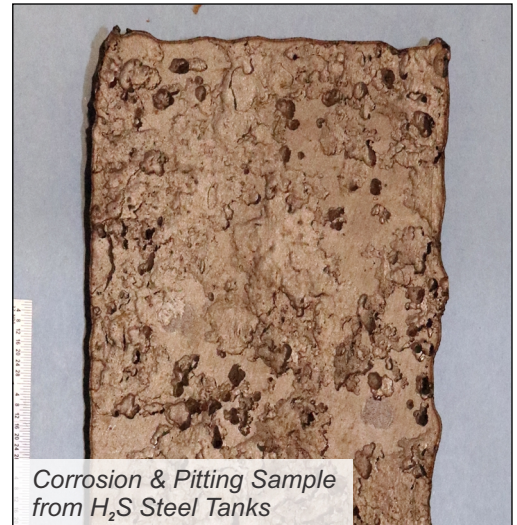
The inner surfaces of the tanks exhibited severe localized corrosion and pitting. Pitting and general corrosion between the pits were observed on the surfaces of each sample. Regions of high sulfur concentration were detected on the surfaces of the cleaned and uncleaned samples. The EDS examination indicated that sulfur was the main corrosive species of the tanks. It was discovered that high concentrations of sulfur on the surface of the tanks led to the crevice corrosion by breaking down the passive layer of the 304 stainless steel. An analysis for fitness for service per API 579 determined that the tanks were structurally unsound and in need of extensive repair.

Corrosion & Pitting Sample from H₂S Steel Tanks

The ESi root cause analysis of the tanks established that they were damaged by the aqueous H₂S corrodent.

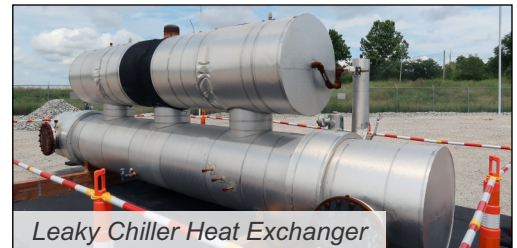
The heat exchanger was found to be leaking internally. The ESi laboratory analysis of the heat exchanger's tubes found no significant corrosion on either the interior or exterior surfaces of the tubes. Further laboratory analysis identified a manufacturing defect in the tube's longitudinal welds that were likely responsible for the reported leaks.

Leaky Chiller Heat Exchanger

The heat exchanger was not damaged due to improper operation or H₂S, but leaked due to pre-existing longitudinal partial penetration welds that apparently grew over time into narrow longitudinal cracks. The cracks were only discoverable under operating conditions when pressure and temperature were applied, and did not appear with the commonly used isothermal pressure testing. A new heat exchanger was constructed as a replacement.

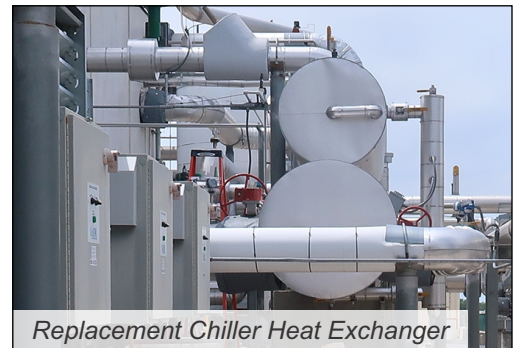
Replacement Chiller Heat Exchanger
