THE LITTLE PLANE THAT COULD: FAILURE ANALYSIS OF A ROBUST TURBINE ENGINE

ESi investigated an issue involving the performance of the high temperature superalloy used in the turbine blades of a commercial aircraft engine. Our findings confirmed the engine was not at fault but rather, a foreign object (likely from an adjacent construction site) entered the engine causing it to ultimately fail.

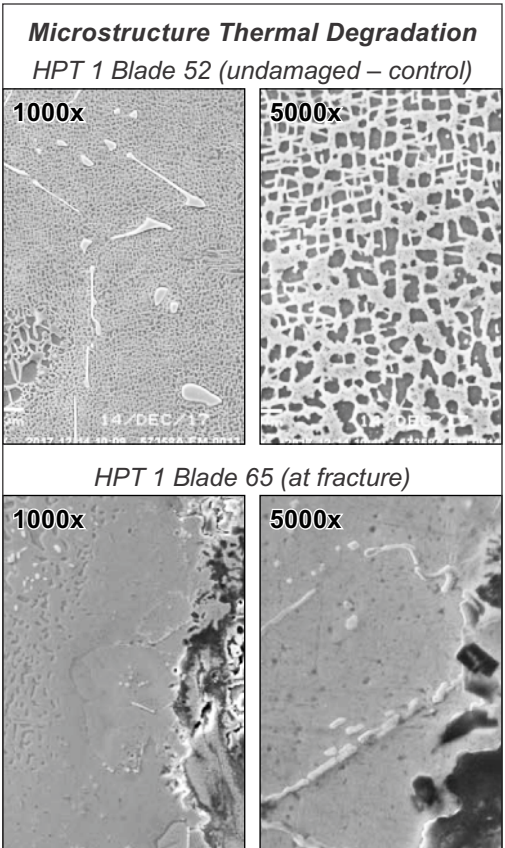
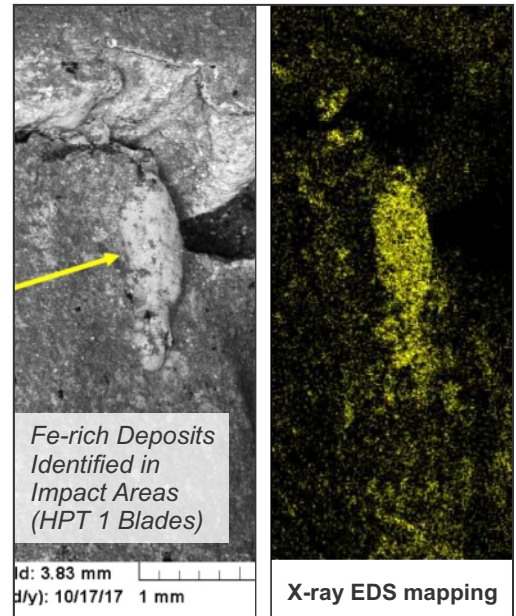
- Macro- and microscopic examinations were performed on several HPT blades, including the initiating failed blade, which had a separated outboard section.
- Fractographic examination of the initiating blade surface revealed overload separation and foreign object damage (FOD) from an iron-based item on the blade's leading edge that had breached the cooling channel.
- Metallographic examination of the internal microstructure of the casting in the FOD area revealed the following:
 - The strengthening precipitates in the superalloy had dissolved due to excessive temperatures experienced as a result of the FOD induced cooling channel breach.
 - The blade's protective aluminide coating had also degraded due to high heat flux in the vicinity of the FOD.

The metal microstructure showed evidence of precipitate "rafting," with geometric rearrangement of the precipitates due to the stress experienced at the excessive temperatures; this rafting is a characteristic phenomenon of creep.

ESi concluded that the engine FOD breached the HPT leading edge cooling channel, disrupting the cooling and exposing the leading edge of the blade to hot turbine gases, which then caused it to overheat. As a result of the high centrifugal rotation force and hot temperatures, the blade experienced metallic creep, extended radially until it contacted the stationary outer shroud, causing sudden overload fracture, secondary damages, and an increase in engine vibration.
