METICULOUS METALLOGRAPHY HELPS CRACK THE CASE

SITUATION

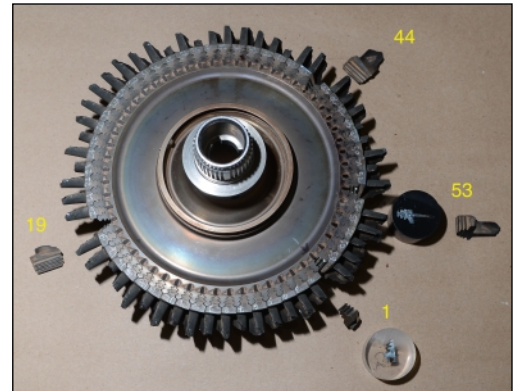
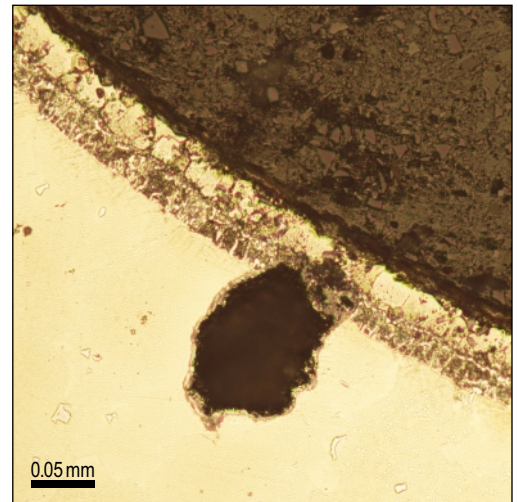
One such discrepant indication was observed from the XCT scan of a sister CT blade, just subsurface at the base of its airfoil section. This location of the blade is normally subjected to small but high frequency bending loads in service and the presence of a void defect could promote the type of fatigue crack initiation and eventual failure as observed in the subject blade. During the inspection, a dispute arose as to whether the XCT scan was identifying a true indication or rather simply it was an artifact of the XCT scan (false indication). Participants agreed to perform metallography on the blade to section, grind, and polish to the location of the internal indication.

Using slices from the XCT scan as a guide, an ESi lab technologist carefully sectioned and mounted the blade in a plane near the XCT scan observed indication. Over the next day and a half, light polishing was performed to methodically remove thin layers of blade material to reach the location of the indication. Some attending experts lamented the tedious process was coming up empty, thereby confirming a false indication. However, one last polishing attempt revealed the indication, identifying it as a near-surface casting pore. This finding confirmed the blade's discrepant condition and raised concerns about the quality of the casting lot as a whole.
