POST-FIRE STRUCTURAL INTEGRITY EVALUATION OF AN AIRCRAFT UTILIZING ASTM E 1004-02

Utilizing fire-damaged components as well as virgin aluminum alloy 2024-T3, ESi developed a clear correlation between electrical conductivity and mechanical properties of damaged and as-specified material. ESi's nondestructive metallurgical evaluation of the Beechcraft model T-34B front CT spar confirmed that its mechanical properties were not affected by the localized fire.

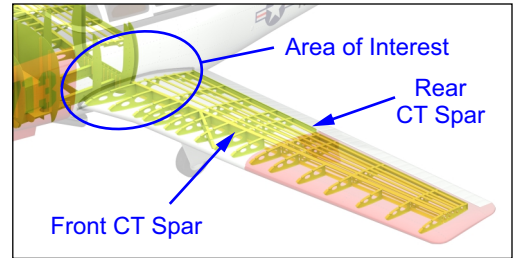
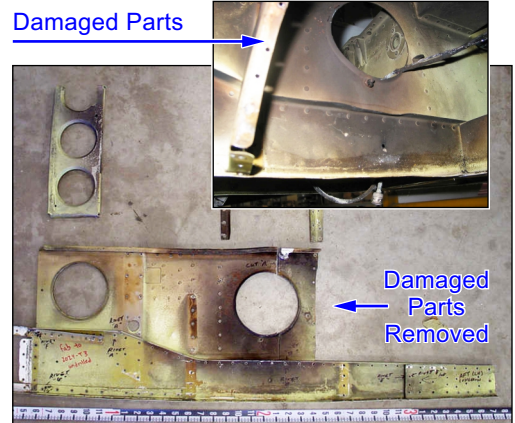
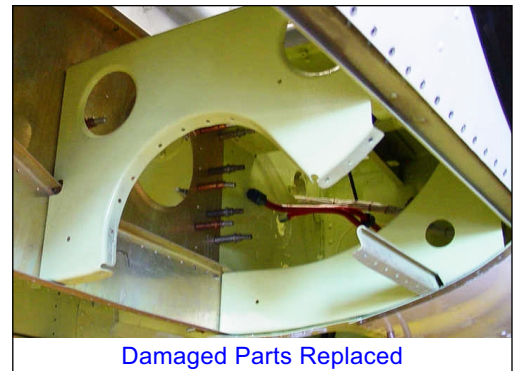
Electrical conductivity for the unaffected regions consistently measured around 33% IACS and was as high as 45.8% IACS in the heat-affected regions, a value approaching the O temper, or fully annealed condition⁶. The typical electrical conductivity value range for aluminum alloy 2024-T3 is 28.5-32% IACS, while the range for O condition is 45.5-49% IACS. Higher electrical conductivity values correlate with decreases in certain mechanical properties. The mechanical properties of the material in the unaffected regions were typical of aluminum alloy 2024-T3. The mechanical properties of the material in the heat-affected regions revealed significant decreases in strength, ductility, and hardness. The fire reached temperatures high enough to transform some of the affected material from the T3 temper to the fully annealed condition.

Although several items showed degraded mechanical properties, measured values for the tested regions closest to the front CT spar were consistent with the unaffected material, indicating heat damage was isolated to a region sufficiently distant from the front CT spar.

Metallographic evaluation revealed no obvious evidence of grain boundary melting or other significant differences between the unaffected and heat-affected regions; however, it was observed that the heat-affected regions on item 2 etched more markedly, suggesting that a physical change had occurred that could account for the measured decrease in ductility.

Once the persistent correlation between the mechanical properties and electrical conductivity was established, the front CT spar was tested. The results confirmed that the fire had not affected the mechanical properties of the front CT spar.
