## TRAIN CONDUCTOR FALL FROM TANK CAR; RECONSTRUCTION OF SAFETY APPLIANCE LOCATION

A train service employee fell from a tank car while attempting to dismount the car. Repairs were made to the car prior to position of the safety appliances (sill step) being measured. ESi performed a 3D scan of the car and reconstructed the original position of the sill step at question, showing that it was within the allowable FRA regulatory requirements.

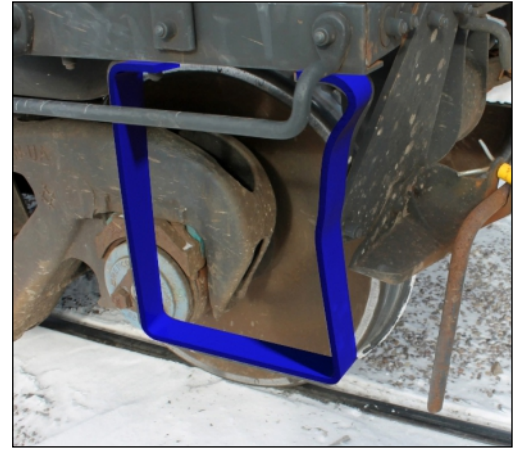
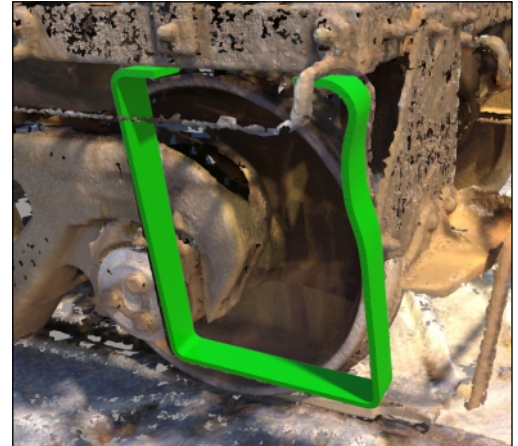
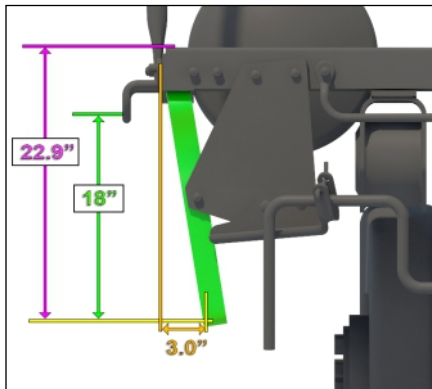
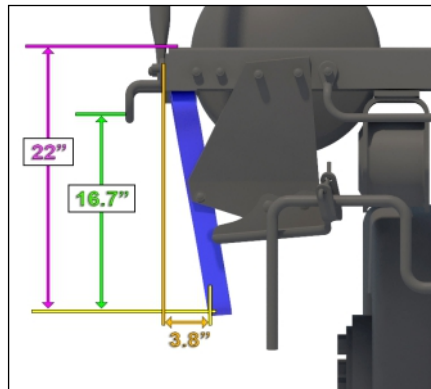
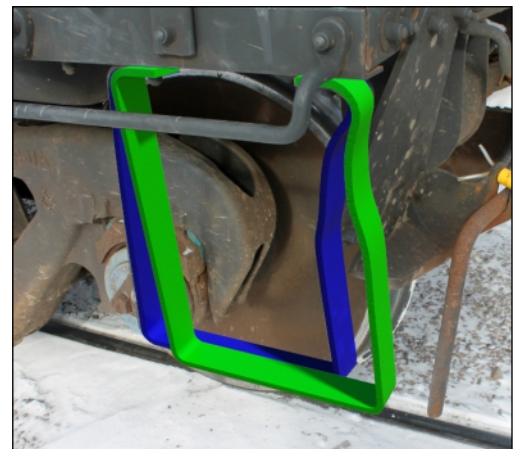
ESi inspected the tank car in question and performed a FARO scan of the entire car with a focus on the safety appliances. A digital model of the tank car was created from the FARO scan and the original photograph taken immediately after the incident was overlaid onto the digital model. The sill step was then digitally "bent" until it matched the sill step in the photograph. The original dimensions of the sill step were then measured and demonstrated that the sill step complied with the FRA safety appliance regulations.

ESi's investigation and analysis evaluated the entire tank car in question and determined the sill step in question was bent inward but, within the allowable range of FRA Safety Appliance Standards. The case settled shortly after the ESi report and analysis were disclosed.
