FAILURE SEQUENCE DETERMINATION OF INDUSTRIAL MACHINERY

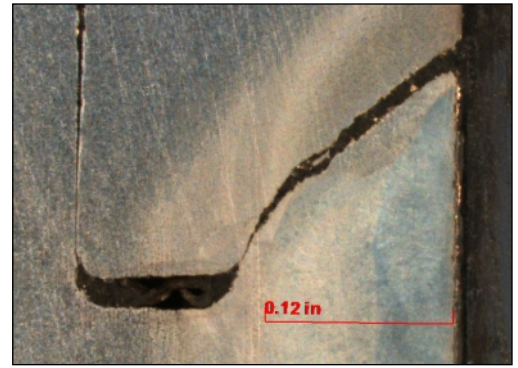
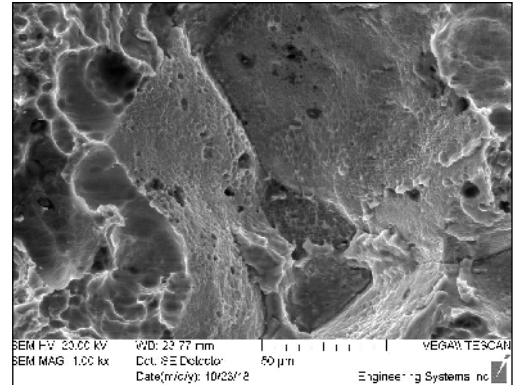
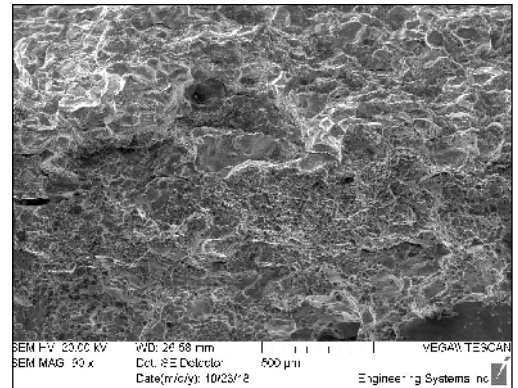
The aluminum air cylinder failed by monotonic (single load application) overload, as evidenced by the ductile fracture appearance on the macroscale and by the microvoid coalescence fracture surface morphology on the microscale. It was clearly a consequence of another component failing first.

The two carbon steel pushrods failed by high cycle fatigue as evidenced by the brittle fracture appearance, beach marks, and ratchet marks on the macroscale and fatigue fracture surface morphology on the microscale. Usually, the determination of fatigue as the failure mechanism would indicate that this component failure was causative and not a consequence of the failure event.

However, careful examination of the low alloy steel ram fracture indicated it also failed by high cycle fatigue. A small fatigue crack originated at the root of the partial penetration weld, which served as a stress raiser. The weld was approximately 33% undersized, which contributed to the failure by increasing the stresses at this location.

The failure sequence was: (1) the ram failed at the weld by fatigue; (2) the load from the ram shifted to the pushrods; and (3) the machinery kept running for tens of thousands more cycles leading to fatigue failure of the two pushrods and instantaneous failure of the air cylinder by monotonic ductile overload.

Based on the results and findings of this multi-component failure analysis, the client was able to efficiently remedy the problems with the new machinery design by addressing the weld defect and, thereby, successfully launch the new product line.
