Metallurgical Failure Analysis of Titanium Wing Attachment Bolts

M.E. Stevenson, J.L. McDougall, and K.G. Cline

Two titanium alloy wing attachment bolts from a commercial jetliner failed during the course of a routine service operation. Failure of the bolts occurred during the re-torque process as the wing was being reattached. Metallurgical failure analysis indicated that the fracture mechanism was ductile overload and that the mechanical properties of the bolts were consistent with exemplar bolts that had been supplied. After eliminating other sources of excessive load application, the most probable cause of failure was ascribed to variances between the frictional characteristics of the bolt at the time of re-torque and at the time of initial torque application several years earlier.

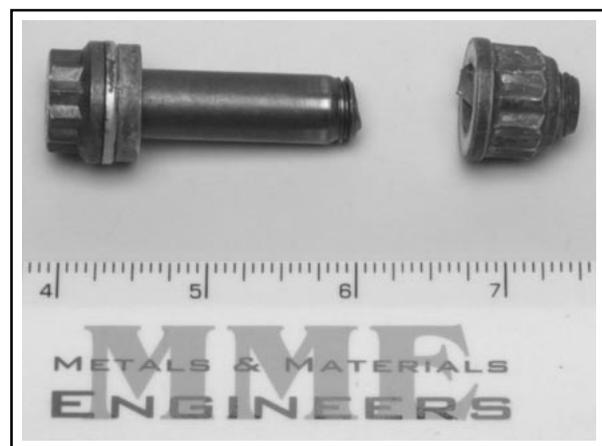
Two fractured wing attachment bolts were submitted for examination, one of which is shown in Fig. 1. The fractured bolts were original equipment

Fig. 1 Photograph of an as-received failed titanium wing attachment bolt

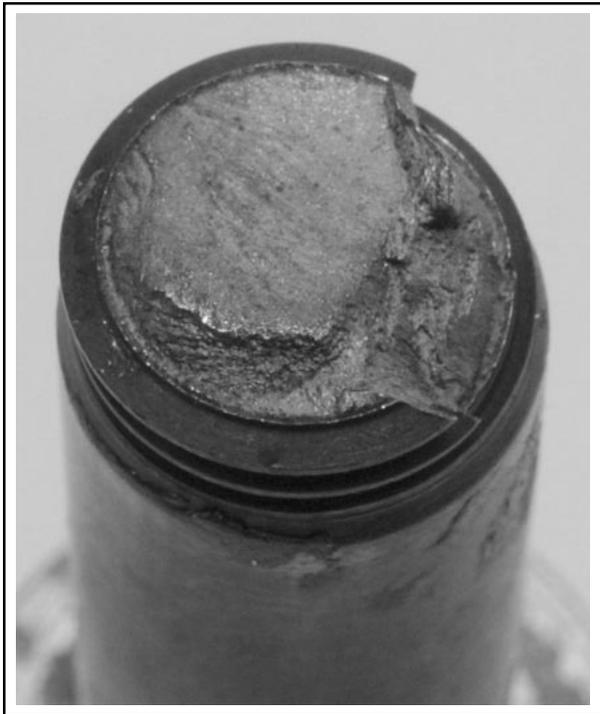
Fig. 2 Higher magnification photograph of the fracture surface shown in Fig. 1

One of the submitted bolts was photographed to document the as-received condition (Fig. 2). Visual examination revealed that both bolts fractured in the vicinity of the last engaged thread root. This fracture location is to be expected because the highest stress concentration and most severe loading would be anticipated to occur in this region.^[3] Little visible evidence of changes in the thread surface condition (i.e., thread compounds, mechanical damage) was discernable. The macroscale appearance of the fracture is quasi-helical, suggesting some degree of torsional loading (common for a threaded fastener).

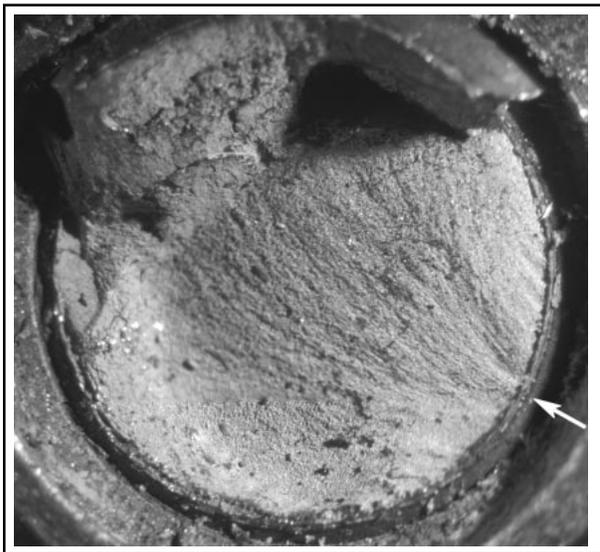
Fig. 3 Composite stereomicroscope photograph of the left-hand bolt fracture surface inside the nut taken under oblique lighting. The fracture origin is denoted by the arrow.

Stereoscopic examination of the fracture surfaces under oblique lighting revealed the fracture origins (Fig. 3). The general appearance of the fracture surface at this length scale is consistent with ductile overload. However, no visual signs of gross macroscopic plastic deformation or fabrication and/or material defects were observed at this length scale.

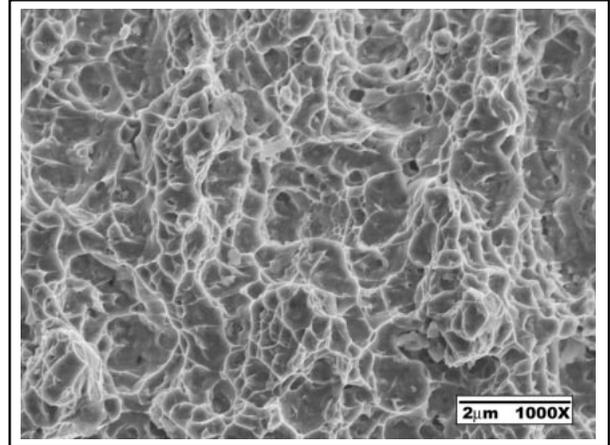
Fig. 4 Scanning electron micrograph (SEM) of microvoid coalescence that characterized the entire bolt fracture surface

Fracture surfaces from both of the fractured bolts were prepared for examination with the scanning electron microscope (SEM) in order to characterize the fracture micromechanism(s). Microvoid coalescence, indicative of a ductile overload, was observed as the only evident fracture micromechanism on both bolts (Fig. 4-6). An apparent “ratcheting” effect was observed on both fracture surfaces. While the wave-like appearance of this portion of the fracture surface would seem to be consistent with cyclic crack progression, it should not be confused with typical fracture surface markings related to fatigue. Possibilities for this fracture surface topography include the microstructural arrangement, events related to the dynamics of the final fracture event, and non-uniform load application during

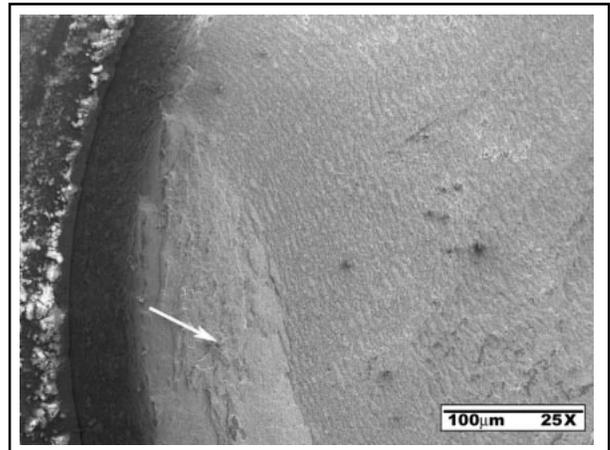
Fig. 5 Lower magnification SEM of the bolt fracture surface. The shear lip (final overload) is denoted by the arrow. Although the fracture surface was characterized completely by microvoid coalescence, a “ratcheting” effect (suggestive of cyclic crack growth or a somewhat discontinuous plastic deformation mechanism) was visible.

the final failure sequence. It is interesting to note that at the macro length scale, these fracture surface markings were resolvable and could be misinterpreted as fatigue arrest lines. Without the aid of electron microscopy, the operative fracture micromechanism would not be completely clear. No evidence of other progressive fracture mechanisms such as stress-corrosion cracking was observed.

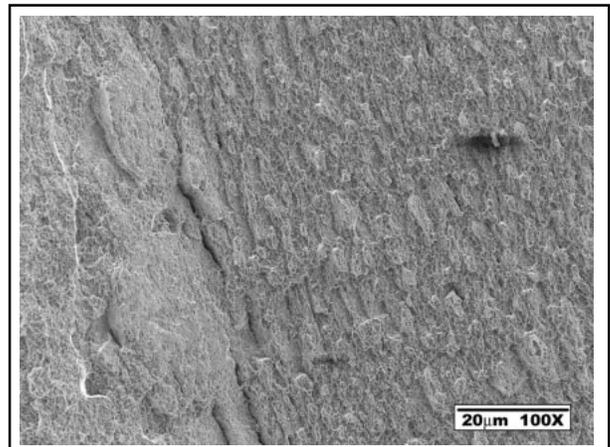
Fig. 6 Higher magnification SEM of the ratcheting effect observed on the fracture surface

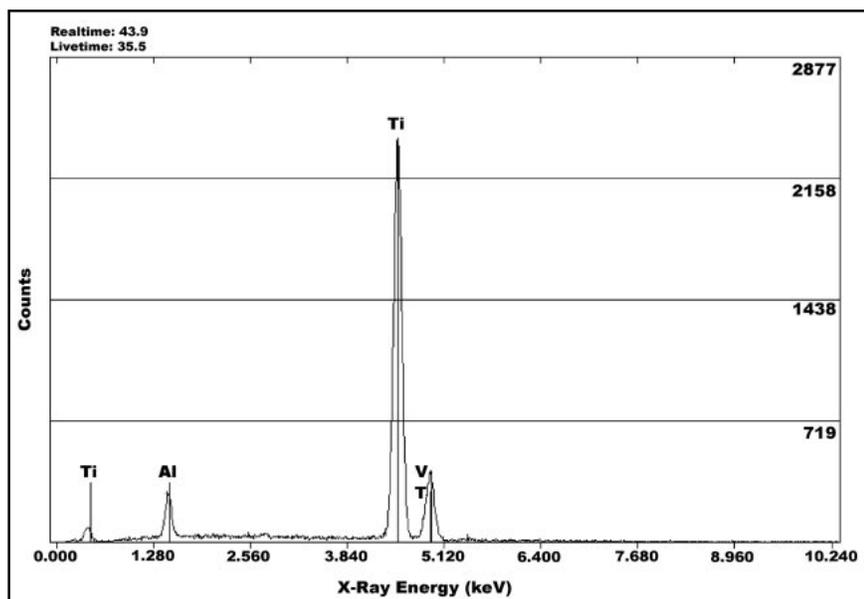
Energy dispersive X-ray microanalysis (EDXA) was used to qualitatively determine the bolt chemistry and to verify the presence of any coatings on the bolt or other associated components. The EDXA results suggest that the bolt material was Ti-6Al-4V (Fig. 7). Evaluation of the thread surface indicated high levels of molybdenum and sulfur, indicative that a thread lubricant consistent with molybdenum disulfide (MoS₂) was present. Examination of the nuts revealed the presence of cadmium plating, common for aerospace fasteners^[4] (Fig. 8).

Fig. 7 Energy dispersive X-ray microanalysis (EDXA) spectrum indicating the nominal bolt chemistry

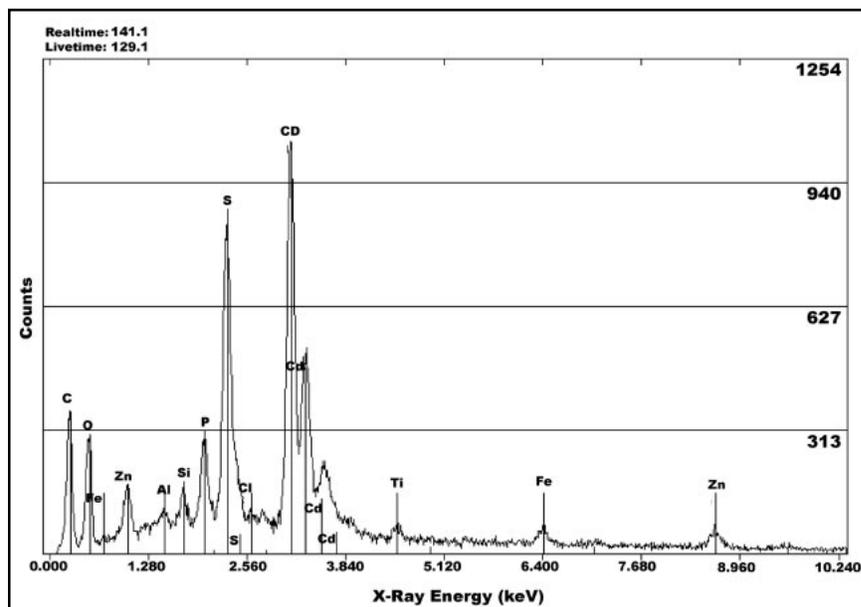
Fig. 8 Energy dispersive X-ray microanalysis (EDXA) spectrum indicating the cadmium plating and the presence of sulfur-based thread compound

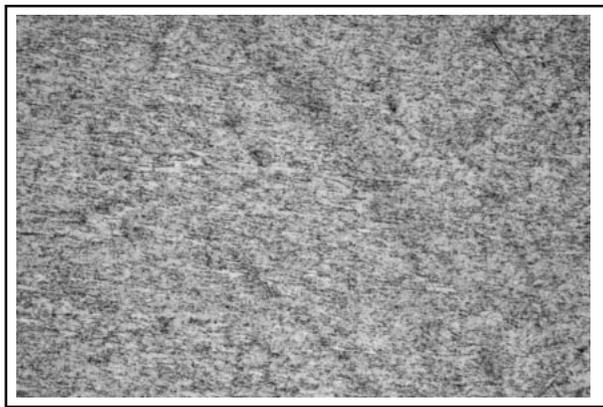
To ascertain the role of microstructure in this failure, a metallographic evaluation was conducted. This evaluation was facilitated by preparing a standard metallographic mount through a longitudinal cross section of a portion of one of the failed bolts and the exemplar bolt. The microstructures of both bolts were duplex in nature and typical of Ti-6Al-4V alloy (Fig. 9). The observed microstructures were

similar and were typical for thread-rolled fasteners. No substantial inclusions or other defects were observed at this length scale. A significant texture sufficient to result in the observed fracture topography was not present.

Fig. 9 Micrograph of the failed right-hand bolt microstructure (Kroll's Reagent; 350× magnification at 6.6 in. width). The duplex microstructure consists of elongated alpha (light) in a beta (dark) matrix.
