Metallurgical and Microbial Aspects of Microbiologically Influenced Corrosion (MIC)

Randy K. Kent, M.S., P.E., Metallurgical Engineer
Susan Evans, CIH, CSP, P.E., Certified Industrial Hygienist / Civil Engineer
MDE, Inc. - Seattle, Washington

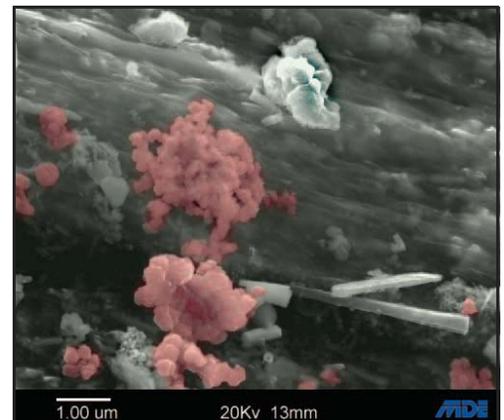
E-SEM Photomicrograph showing likely SRB cocci

- Sulfate-Reducing Bacteria (SRB) – bacteria that converts sulfate ions to sulfides (including hydrogen sulfide). These bacteria can grow in low oxygen environments. SRB require sufficient organic nutrients.

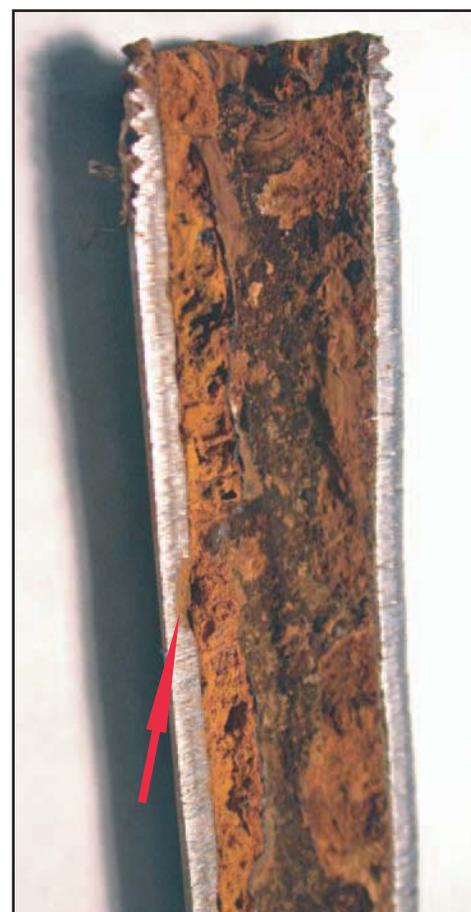
Cross-section of galvanized pipe showing MIC effects. Note: pitting has reduced wall thickness by 60%.
