## JET FIGHTER ACRYLIC CANOPY FAILURE

### SITUATION

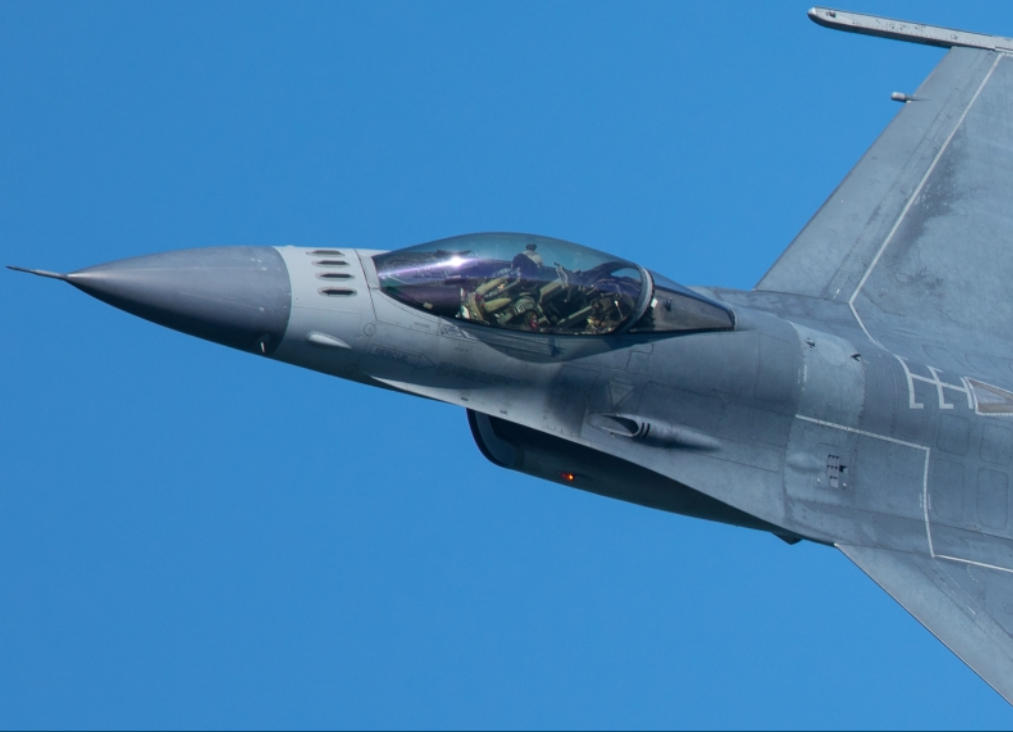
The aft and forward polymethylmethacrylate (PMMA) or acrylic canopies on the same fighter jet failed in mid-flight on two separate occasions just four months apart. The subject aircraft spent many hours at high temperatures (roughly 90°C) while idle on the ramp. In flight, the outside temperatures were much lower (roughly 0°C). Brown stains were observed around the edges of the canopies and a chemical compatibility issue with the sealant was suspected by the client. A few months before the incidents occurred, the canopy had accidentally been exposed to hydraulic fluid and may have been cleaned with alcohol.

The fracture surfaces of the failed transparency displayed features indicative of monotonic overload failure initiating at the fastener holes under bending loads with the transparency inner surface under tension and the outer surface under compression. No evidence of fatigue or environmental stress cracking was observed. The numerous chemical, thermal, and mechanical tests conducted indicated no evidence of material degradation occurred due to weathering, oxidative aging, heat aging, or physical aging. Stress analysis demonstrated that the added stress due to pressurization was very low (<200 psi). Furthermore, the predicted in-flight stresses in the transparency were much lower than the material tensile strength. The critical flaw or crack size was determined to be approximately 0.05 inch (1.3mm).

The most likely failure scenario is the existence of crack-like defects combined with the decrease in fracture toughness due to low temperature (high altitudes) and/or exposure to detrimental chemicals (i.e., stress cracking agents). Procedures were recommended to assure that any crack-like indications were <1mm and that the transparencies would not be exposed to detrimental chemicals.
