FAILURE SEQUENCE DETERMINATION OF INDUSTRIAL MACHINERY

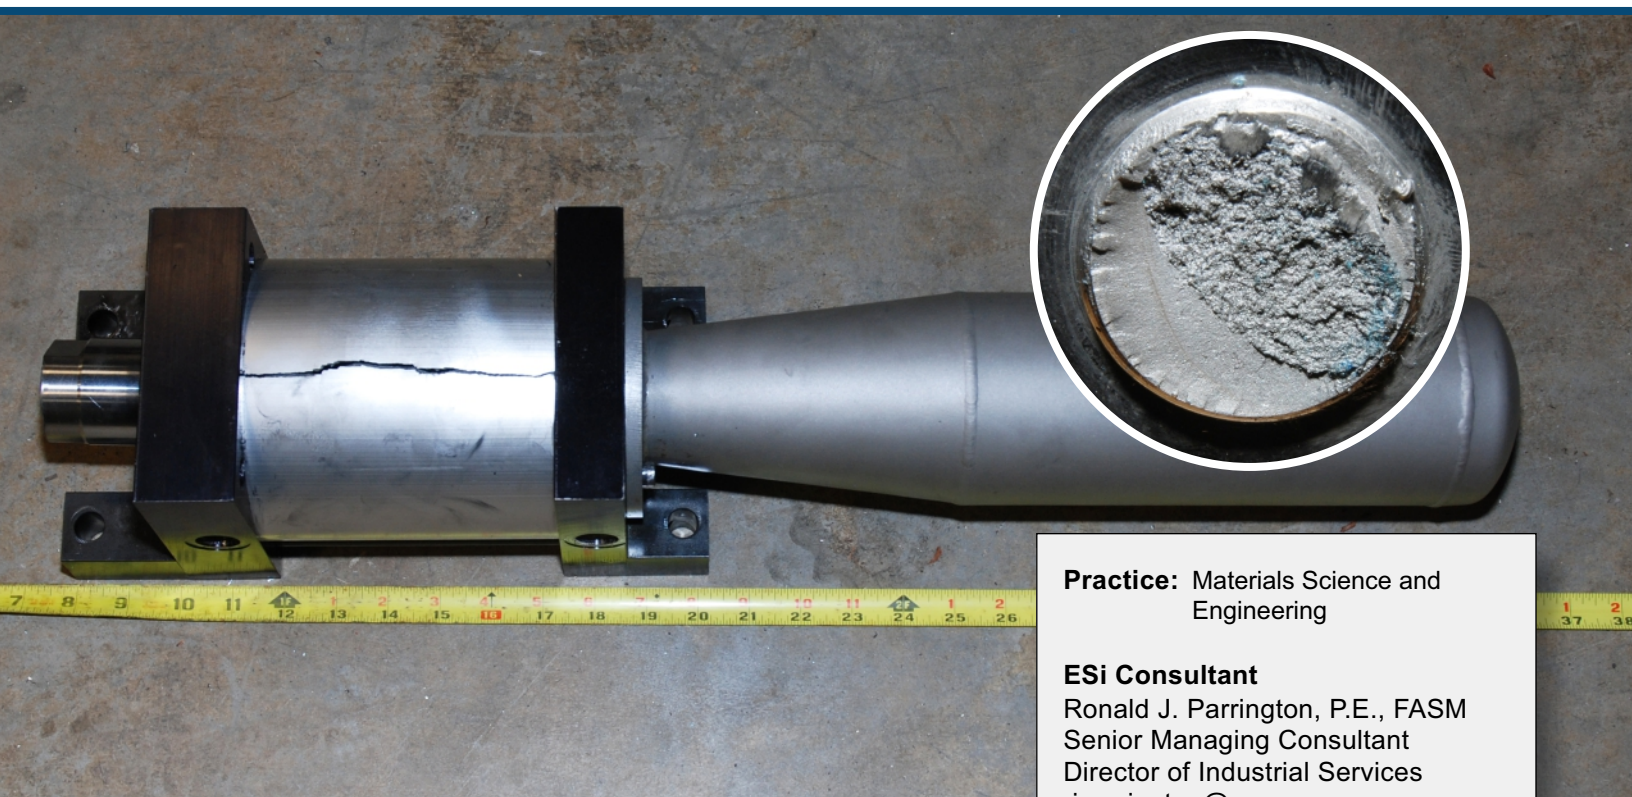
However, careful examination of the low alloy steel ram fracture indicated it also failed by high cycle fatigue. A small fatigue crack originated at the root of the partial penetration weld, which served as a stress raiser. The weld was approximately 33% undersized, which contributed to the failure by increasing the stresses at this location.

The failure sequence was: (1) the ram failed at the weld by fatigue; (2) the load from the ram shifted to the pushrods; and (3) the machinery kept running for tens of thousands more cycles leading to fatigue failure of the two pushrods and instantaneous failure of the air cylinder by monotonic ductile overload.

Based on the results and findings of this multi-component failure analysis, the client was able to efficiently remedy the problems with the new machinery design by addressing the weld defect and, thereby, successfully launch the new product line.
